NAVAL POSTGRADUATE SCHOOL  
Monterey, California

THESIS

AN INVESTIGATION OF PLASMA - SURFACE  
INTERACTIONS ON SELECTED  
CONDUCTORS AND INSULATORS.

Dec 1980

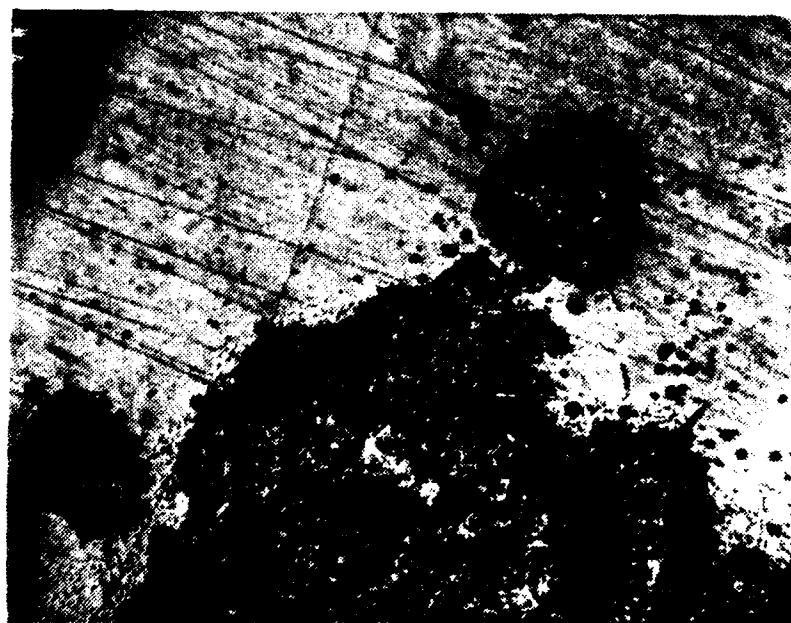
A 0.375 mm thick sample of copper was prepared and irradiated in the test chamber at a vacuum of  $10^{-6}$  torr. The power of the laser beam was 3 joules resulting in a damaged area 2 mm in diameter. Figures 29 and 30 show the outer perimeter of the damaged area. The dark areas scattered outside of the major damaged area were probably caused by a plasma-surface interaction.

FIGURE 30. COPPER IRRADIATED IN A VACUUM SHOWING DAMAGE AT PERIMETER OF THE MAIN CRATER. (200X OPTICAL MICROSCOPE)

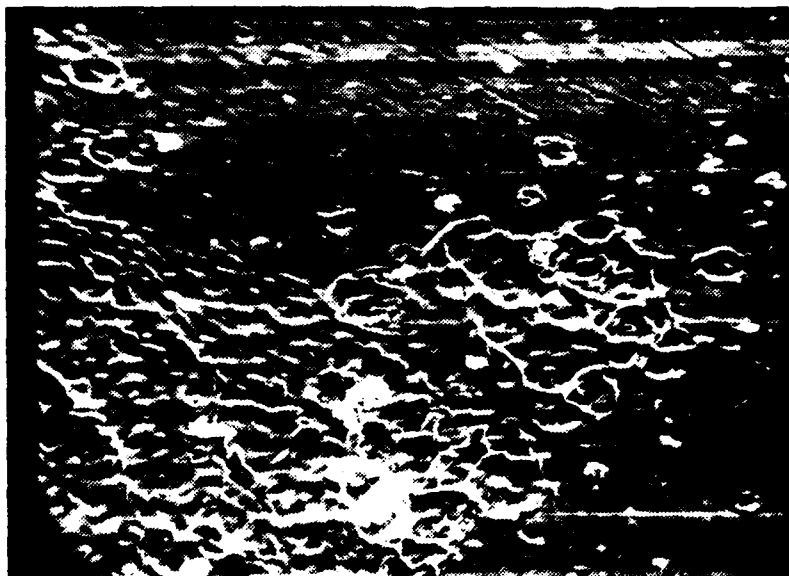
The center of the 25  $\mu$ m deep main crater is shown in Figure 31. The layered rosette pattern indicates that the copper sample was in a highly molten state for a relatively long time. Figures 32 to 34 show the many dimpled craters formed around the outer perimeter of the damaged area. The larger craters were formed first while the younger craters appear as small dimples. The many new craters, seen at the top of Figure 33, average .002 mm in diameter. The larger craters are .015 mm in diameter and 2 to 4  $\mu$ m deep.

FIGURE 33. COPPER IRRADIATED IN A VACUUM SHOWING OUTER PERIMETER OF THE  
MOLTEN DAMAGE AREA. (500X SEM)

Comparing Figures 31 and 36 show that the copper experienced a much more violent reaction to the laser pulse when it was irradiated in a vacuum than at atmospheric pressure. The size and density of the unipolar arcing craters is much greater in the vacuum than at atmospheric pressure. In Figure 33 (vacuum) the unipolar craters are 12.5  $\mu\text{m}$  in diameter and their density is about 2000 per  $\text{cm}^2$ . In Figures 37 and 38 (atmospheric pressure) the unipolar craters are 8-10  $\mu\text{m}$  in diameter and their density is still about 2000  $\text{cm}^2$ .

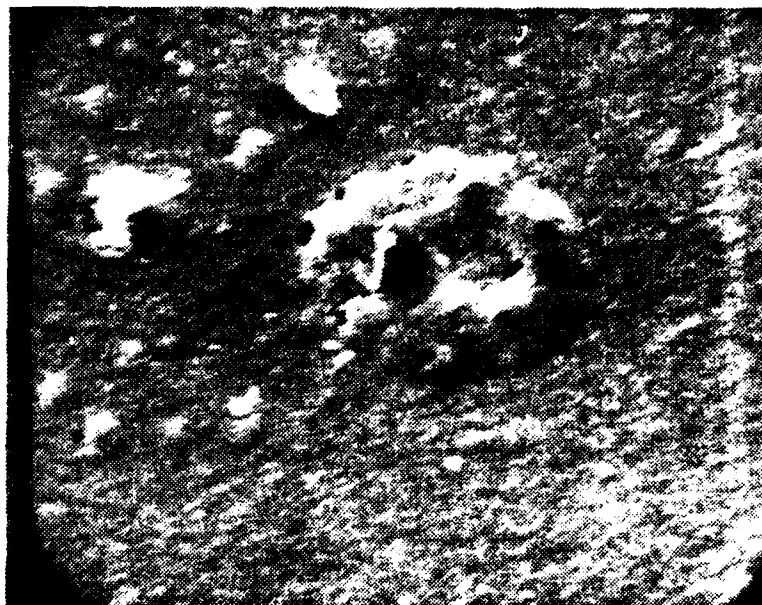
FIGURE 78. GLASS COATED WITH TITANIUM SHOWING GREY COLORED SECTION OF THE SAMPLE. (500X SEM)

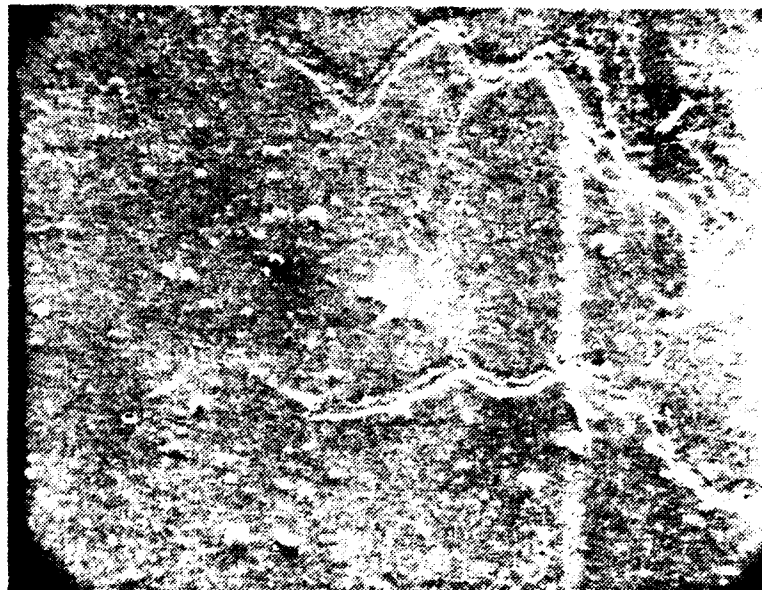
The grey half of the tube is shown in Figures 77 to 80. This part of the tube seems to be coated with a fine powder. The imperfections on the surface appear to be raised areas rather than depressed cratered areas. Figure 79 was taken near the sample's edge. The light grey area at the bottom right of the picture is a patch of metallic glue that was used to hold the SEM sample. A bright piece of debris is in the photograph's center. Branched, river-like patterns are at the photograph's right. A magnified view of these river patterns, Figure 80, does not distinctly show whether or not these river patterns were caused by arcing. It is possible that arcing formed the river patterns and then the craters were covered with a layer of titanium.

FIGURE 80. GLASS COATED WITH TITANIUM SHOWING THE GREY COLORED SECTION OF THE SAMPLE. (100X SEM)
